INSPECTION REPORT

For the Property at:
123 SOUTH MAIN STREET
NORTH CANTON, OH 44720

Prepared for: JOHN DOE
Inspection Date: Friday, December 3, 2021
Prepared by: Goran Atanackovic

Report No. 1268, v.3

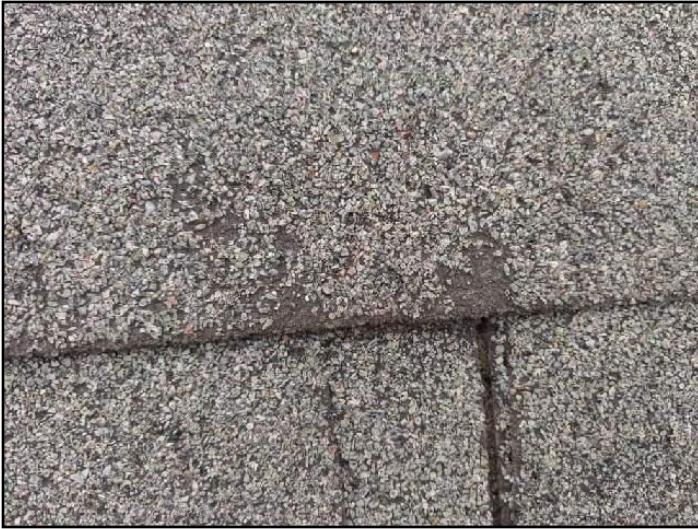
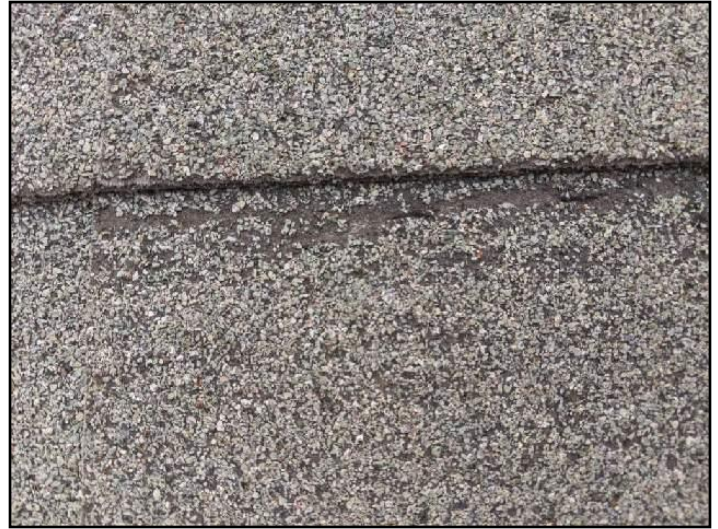
Condition: • Debris/moss

Moss is growing between the shingles. This can prematurely deteriorate the shingles and the sheathing below. I recommend cleaning the moss with a mild solution to prevent premature damage.

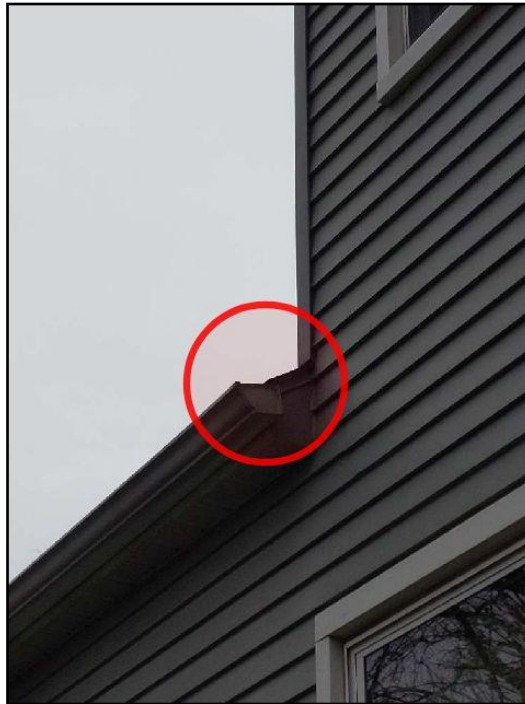
Condition: • The sealant is beginning to crack and has slightly deteriorated. This may be a vulnerable area for moisture intrusion during inclement weather. The sealant should be improved when time is practical.

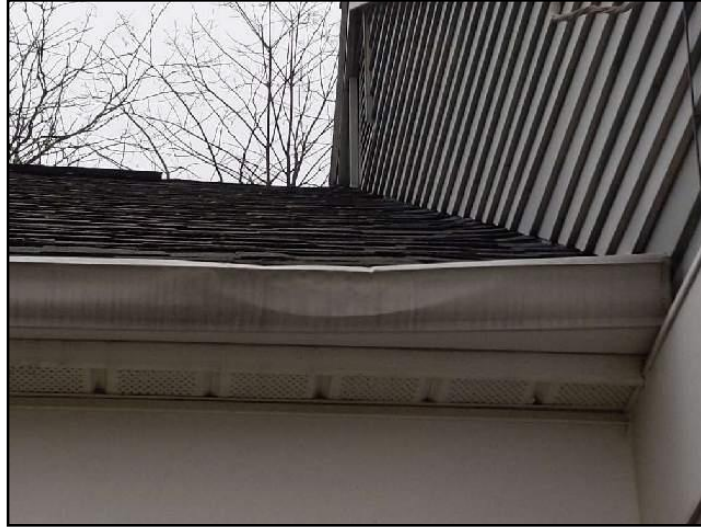
Condition: • [Discharge onto roofs](#)

The downspout are discharging onto the roofing material. This may prematurely deteriorate the shingles and may cause damage to the sheathing below. Downspouts should extend to the gutter directly below for proper drainage.

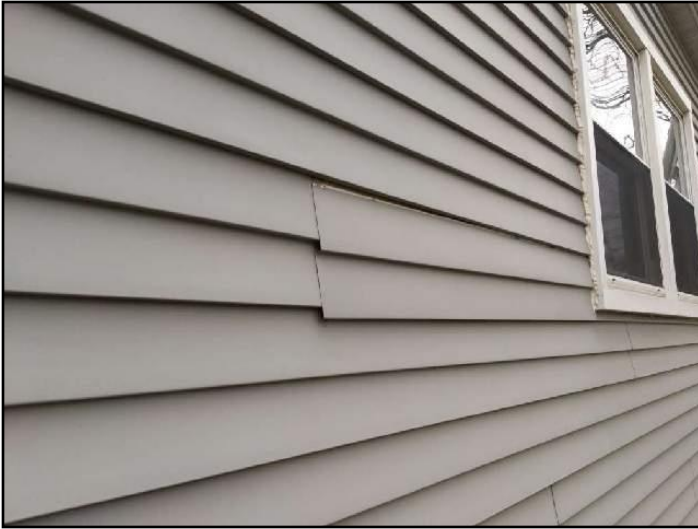
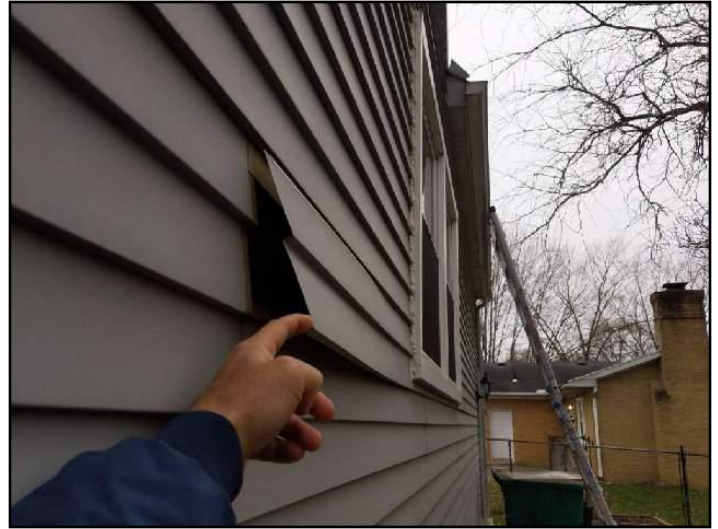
Condition: • These are vulnerable areas to moisture intrusion. Approved sealant should be applied in these areas to prevent moisture issues.

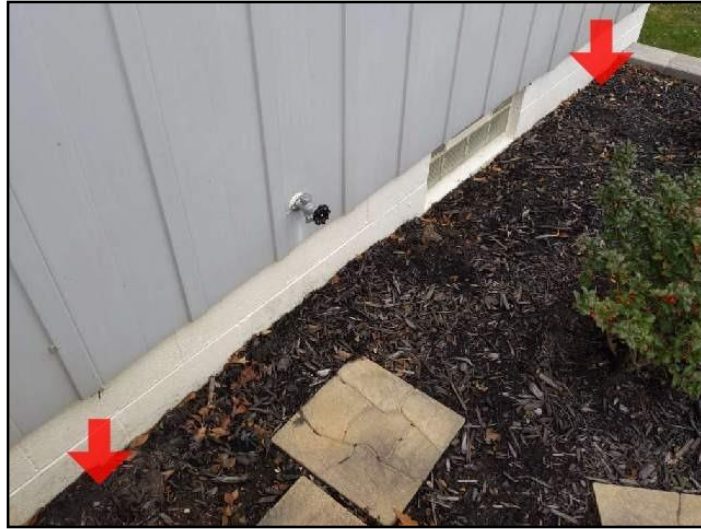
Condition: • [Cracked or damaged surfaces](#)

The concrete has cracked over time due to settlement. The crack should be filled with an approved sealant to prevent further cracking and damage.

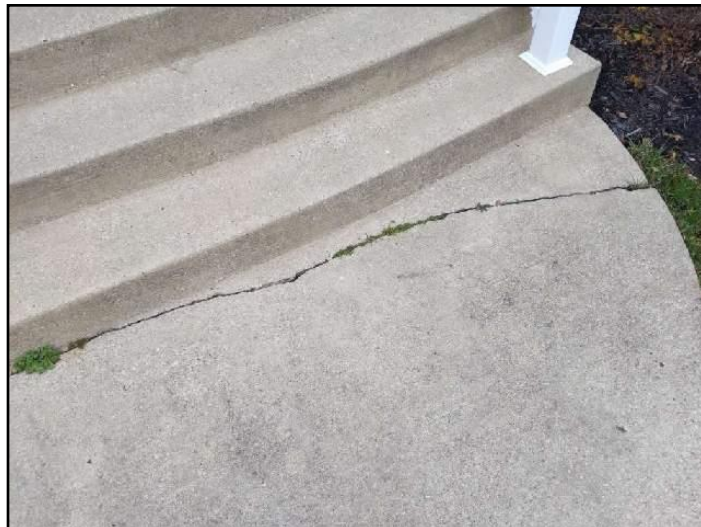
Condition: • Cracked or damaged surfaces

The patio has cracked due to settlement over time. The patio should be sealed with an approved sealant to prevent further cracking and damage.

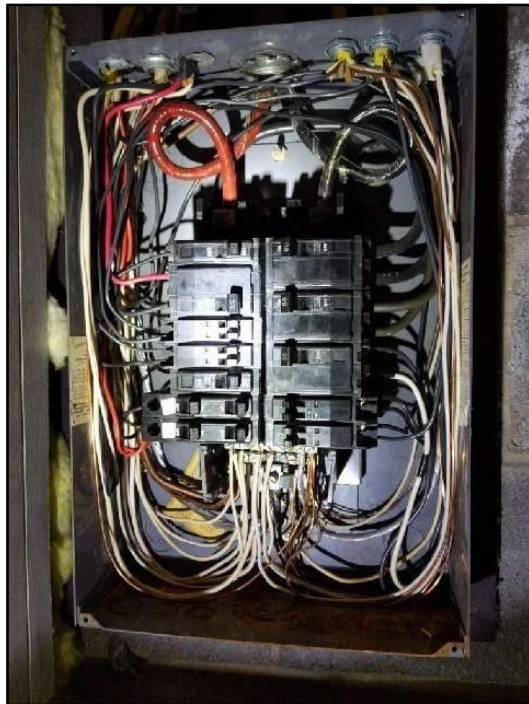
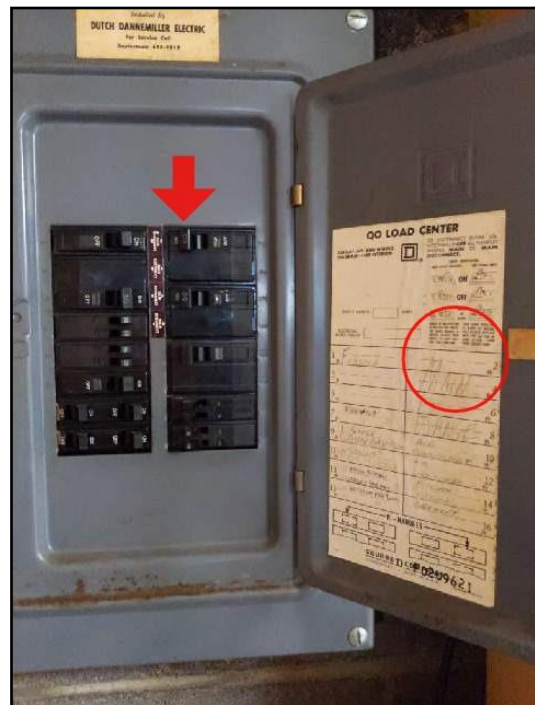
Condition: • [Illegal taps](#)

Illegal taps were observed on the bus bar. An illegal tap occurs when two wires (ground and neutral) or (neutral and neutral) and three or more grounds are under the same lug on a bus bar. If both the neutral and grounded conductor is under the same terminal, equipment ground cannot be accomplished.

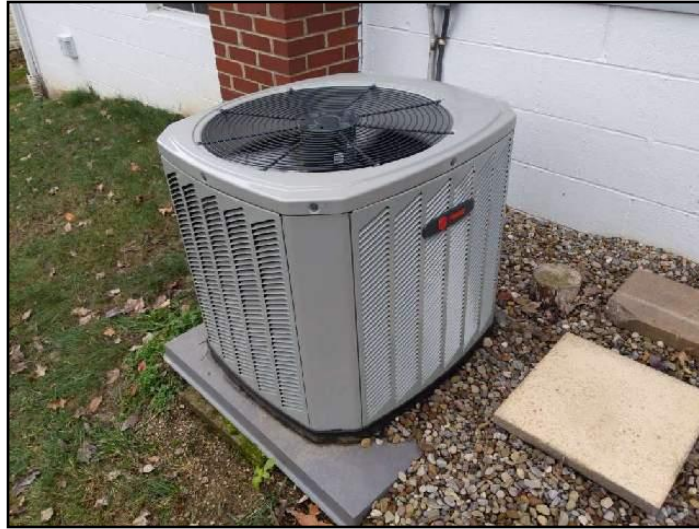
Condition: • [Insulation - missing](#)

The insulation has deteriorated around the refrigerant line. This will cause the refrigerant to lose its cooling effectiveness. I recommend insulating the line for proper cooling capacity.

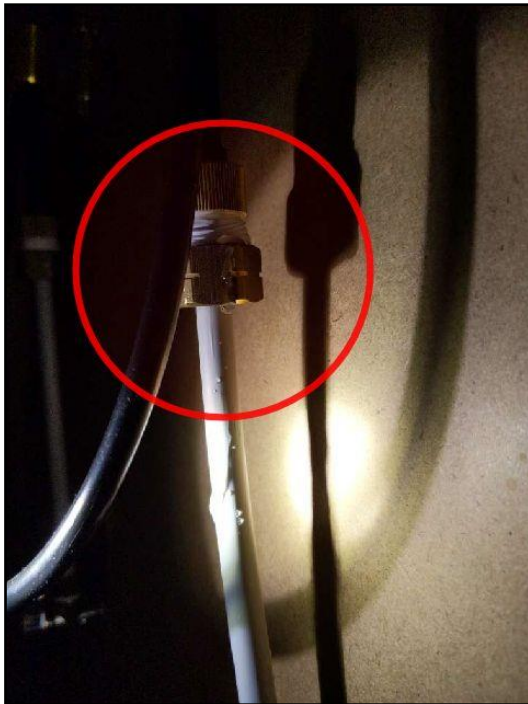
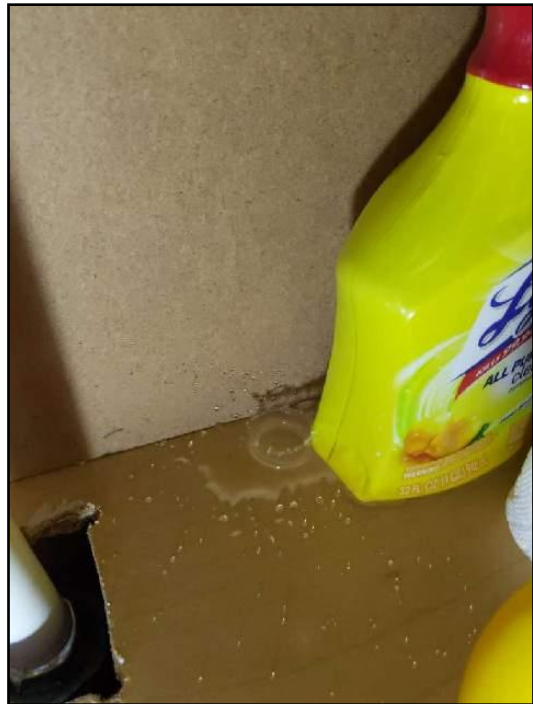
Condition: • [Leak](#)

There's a small leak at the threaded pipe. The leak should be repaired to avoid damage to the vanity.

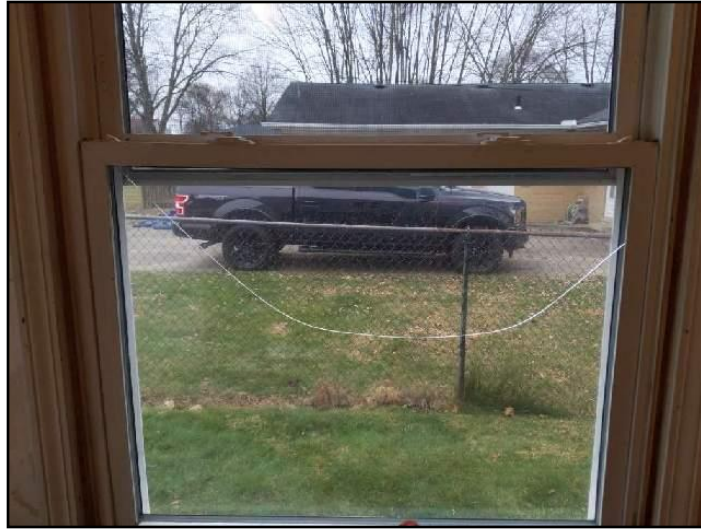
Condition: • [Lost seal on double or triple glazing](#)

The windows have lost their seals, creating a fog between the window panes. Once the seal fails, moisture is allowed to seep into the space between the two pieces of glass. I recommend hiring a qualified window contractor to repair the windows.
