INSPECTION REPORT

For the Property at:
123 SOUTH MAIN STREET
NORTH CANTON, OH 44720

Prepared for: JOHN DOE
Inspection Date: Friday, December 3, 2021
Prepared by: Goran Atanackovic

Report No. 1268, v.3

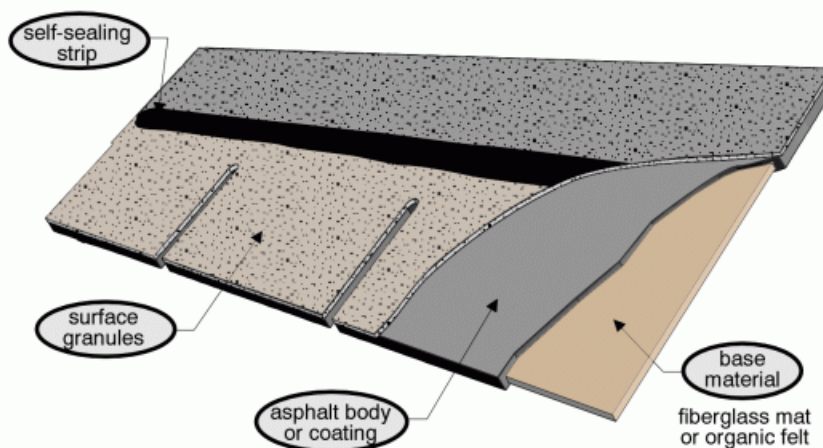
Asphalt shingle composition

Condition: • [Granule loss](#)

The shingles have suffered granular loss and the fiberglass mat is exposed in areas. Granular loss is normal but the designed protection from shingles decreases. The shingles are in relatively good shape and those areas should be monitored for further deterioration. No leaks were detected during the inspection on the inside of the home. The shingles will need to be replaced in the future.

Implication(s): Chance of water damage to structure, finishes and contents

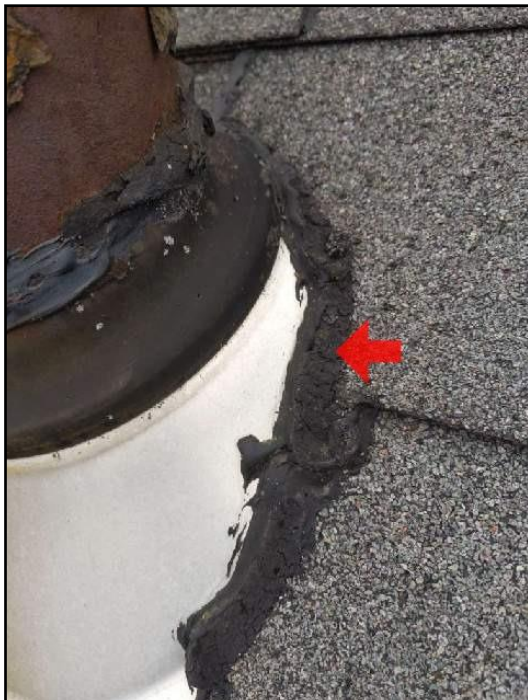
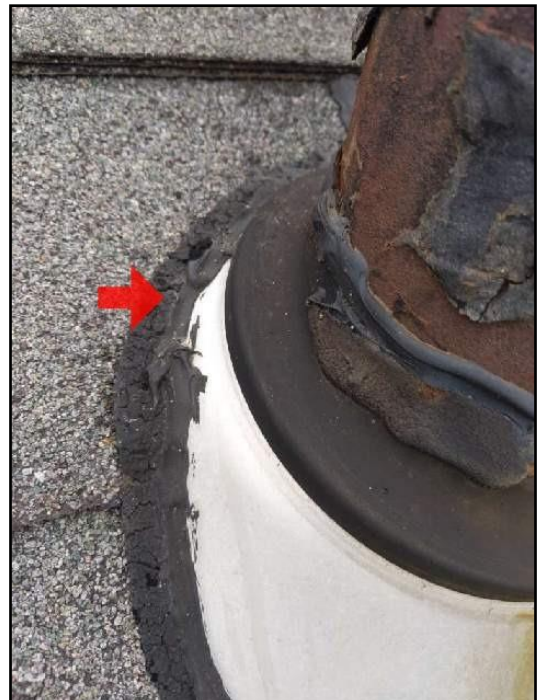
Location: Front of Home

Condition: • The sealant is beginning to crack and has slightly deteriorated. This may be a vulnerable area for moisture intrusion during inclement weather. The sealant should be improved when time is practical.

Task: Improve and Monitor

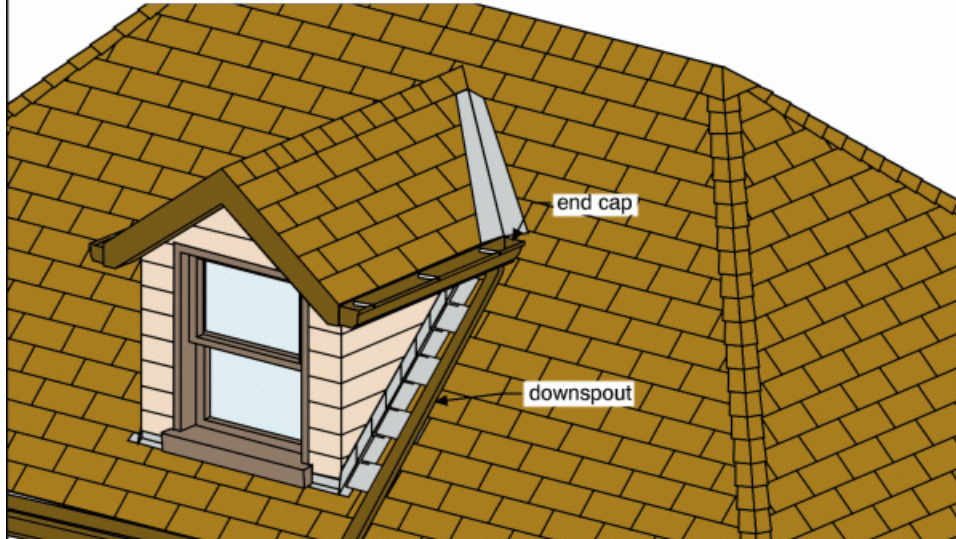
Downspout running across roof

Condition: • [Discharge onto roofs](#)

The downspout are discharging onto the roofing material. This may prematurely deteriorate the shingles and may cause damage to the sheathing below. Downspouts should extend to the gutter directly below for proper drainage.

Implication(s): Chance of water damage to structure, finishes and contents

installing a downspout (from the secondary roof to the main gutter below) helps prevent localized roof wear

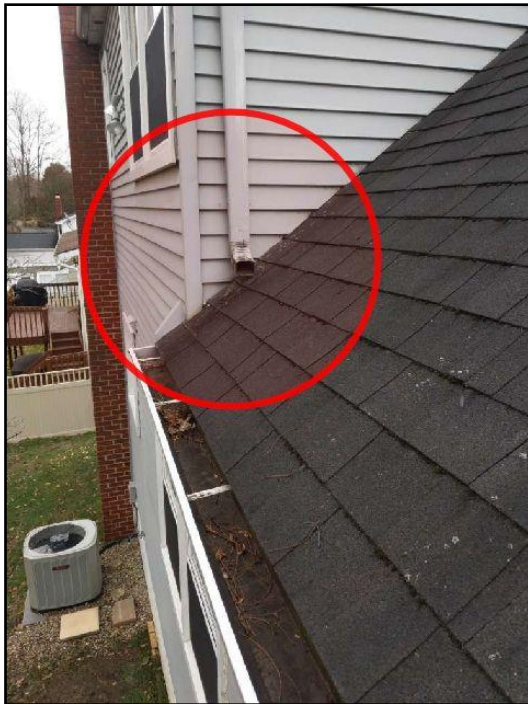
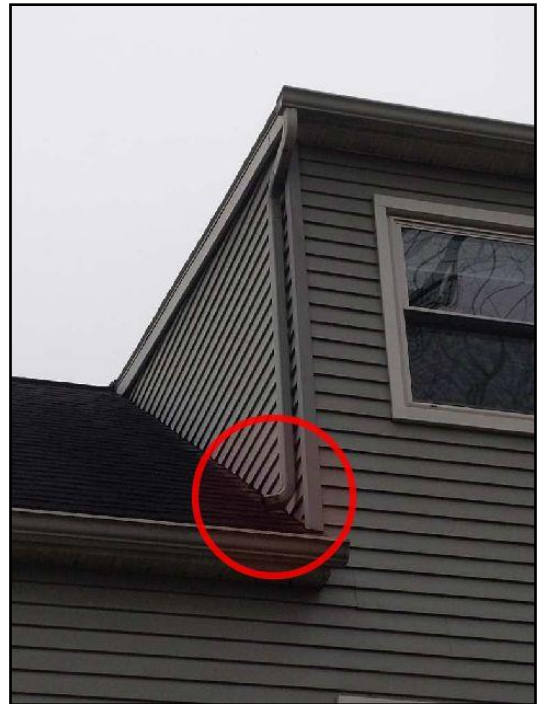
Condition: • [Loose or missing pieces](#)

The siding has loosened. This may be a vulnerable area during high winds. The siding should be secured properly.

Implication(s): Chance of water damage to structure, finishes and contents

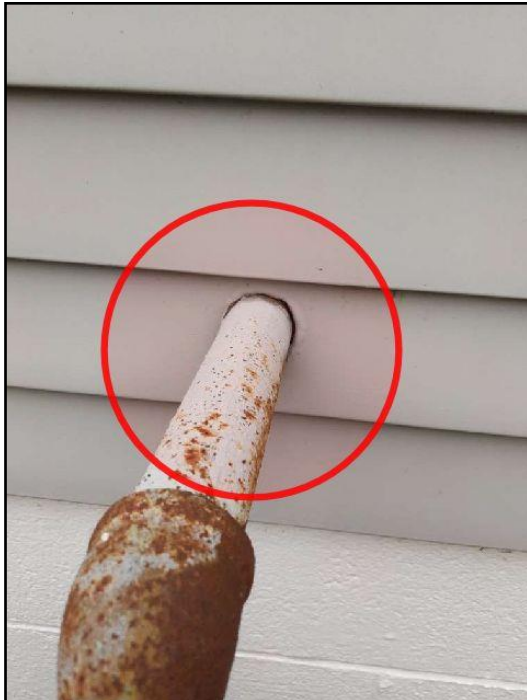
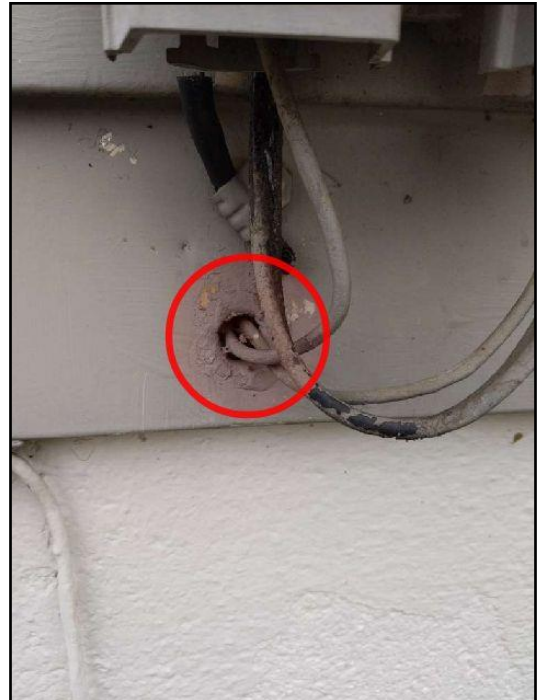
Location: Southeast Corner of Home

Condition: • These are vulnerable areas to moisture intrusion. Approved sealant should be applied in these areas to prevent moisture issues.

Task: Improve

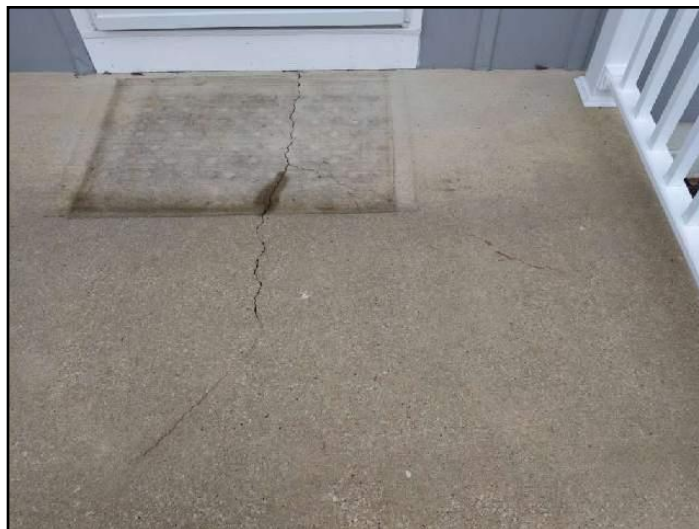
Location: Front of Home

Condition: • The concrete has cracked. This is a vulnerable area for moisture intrusion and further damage. Approve sealant should be applied to the crack and monitored.

Task: Improve and Monitor

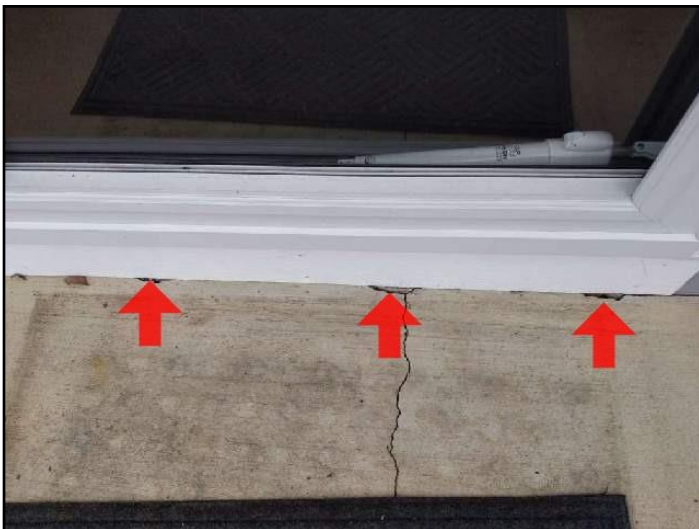
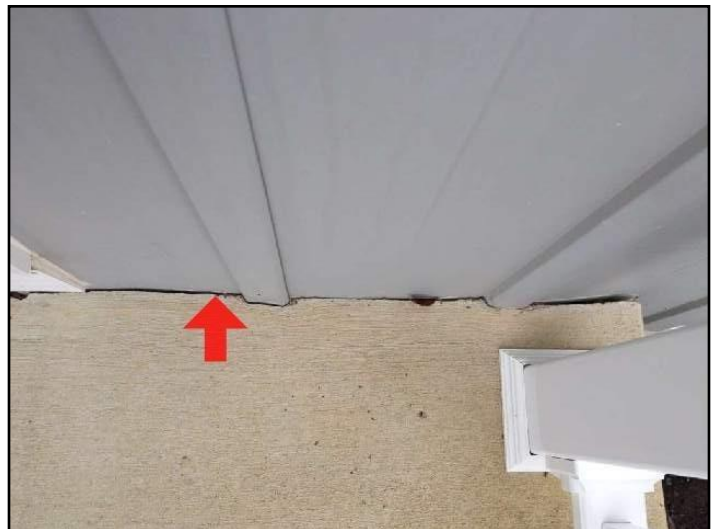
Condition: • Unsealed gap at building

Void spaces were observed between the porch and foundation. An approved sealant should be applied to this area to prevent moisture intrusion.

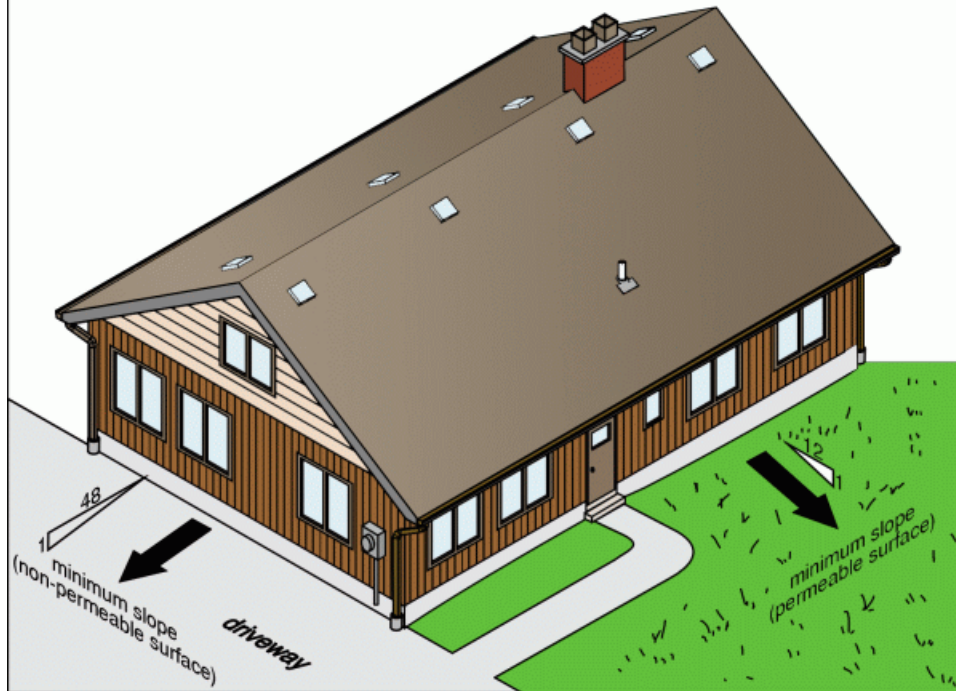
Recommended grading slopes

Condition: • [Improper slope or drainage](#)

The grading is flat to negative, allowing water to drain towards the foundation wall. I recommend improving this by grading the soil back, bringing in topsoil, and grading the topsoil away from the foundation walls for proper water drainage. If left untreated, water will eventually cause the blocks to deteriorate and water may enter the structures. A window well maybe required at the front basement window to improve the grading. If a well is installed, a plastic well cover should be installed to prevent moisture issues.

Implication(s): Chance of water damage to structure, finishes and contents

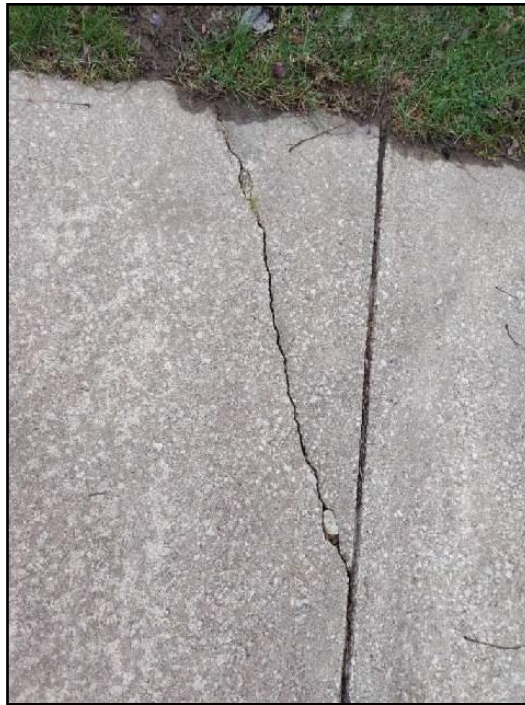
Condition: • Unsealed gap at building

The gap between the patio and the house foundation is not sealed. This is a vulnerable area for moisture intrusion and potential damage to the foundation wall over time. This area should be sealed with an approved sealant to prevent any moisture issues.

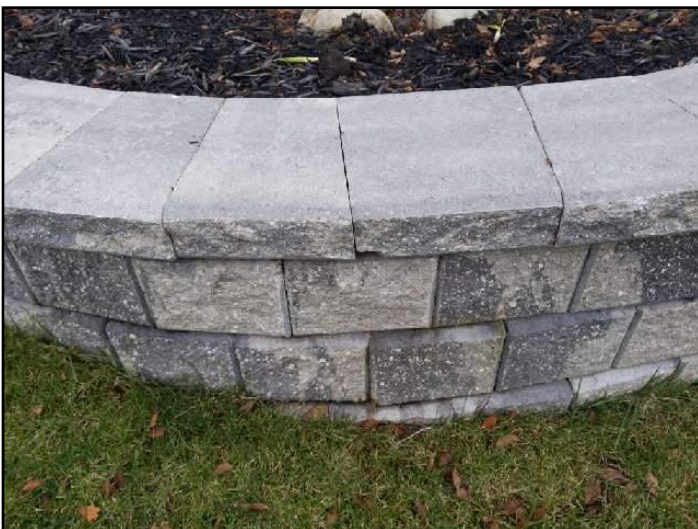
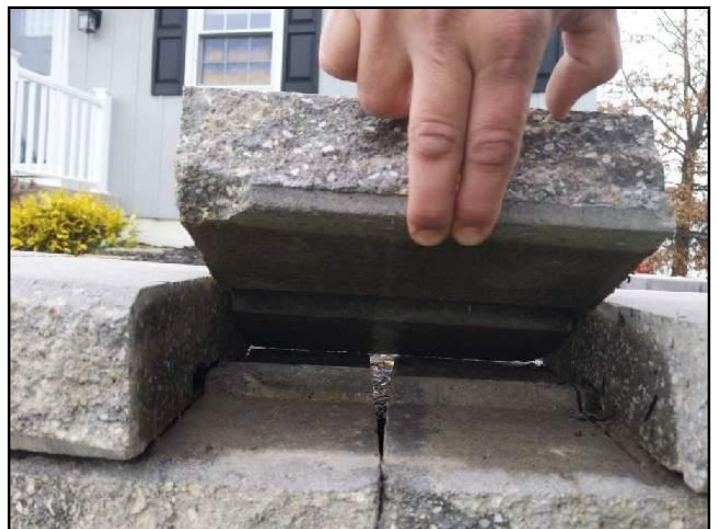
Condition: • The top caps are not glued to the blocks. Appropriate adhesive should be applied to the top caps for increased wall durability and to help restrict wall movement.

Location: Throughout Retaining Wall

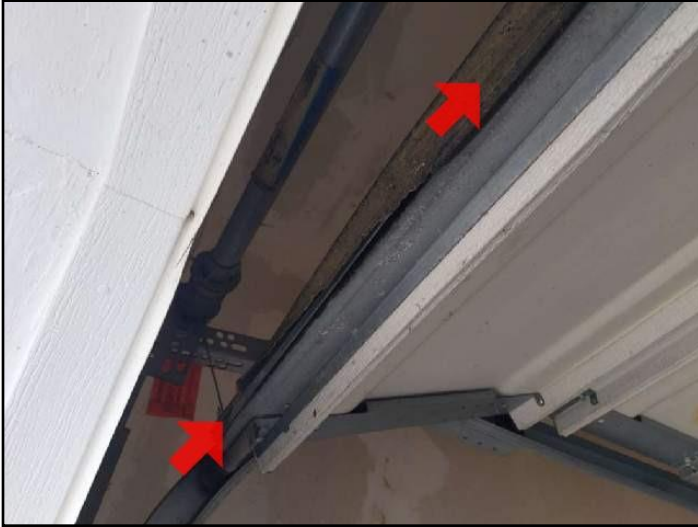
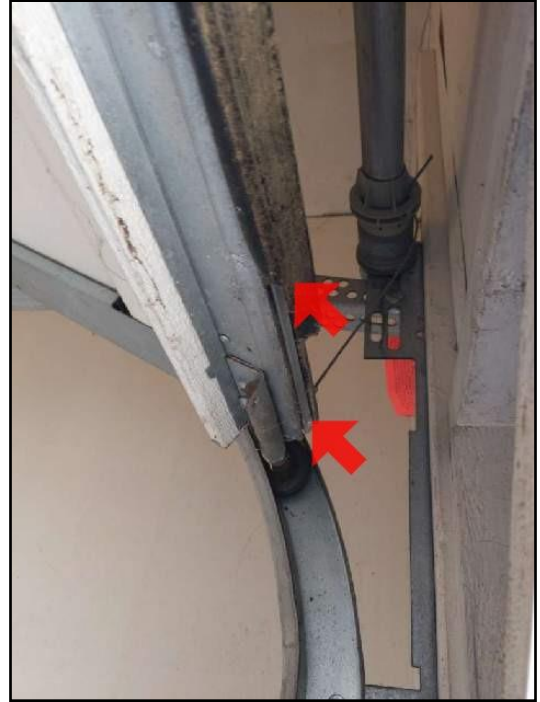
Condition: • Weatherstripping damaged or missing.

The weather stripping at the base of the garage door has deteriorated. Weather stripping is designed to insulate the garage and to prevent moisture / pest intrusion.

Location: Garage

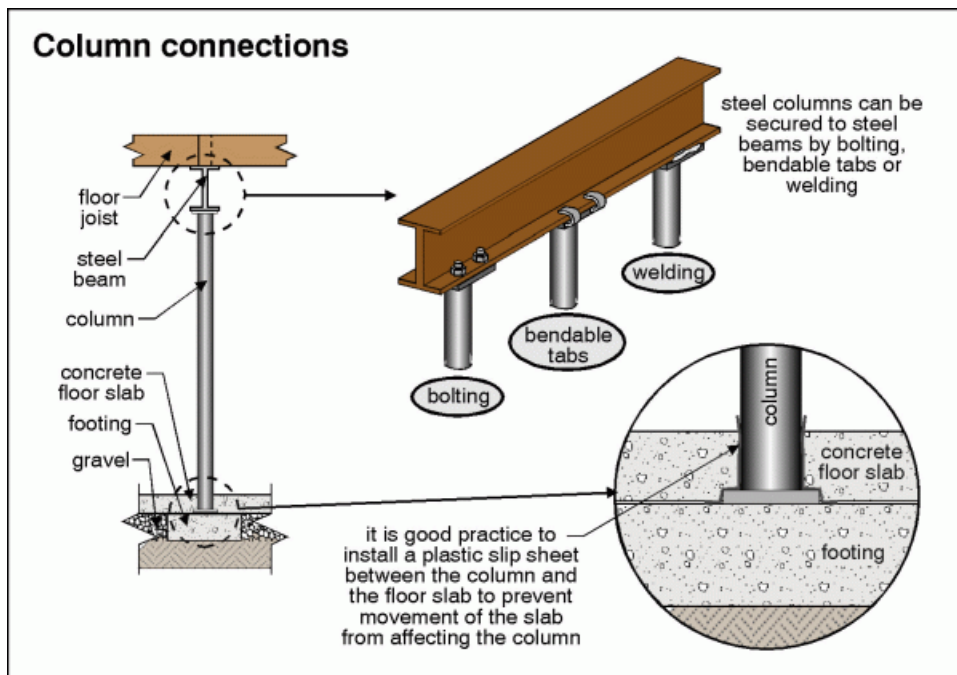
Condition: • [Poorly secured at top or bottom](#)

The columns should be secured on top for better support. The columns should be secured with 1/2" diameter x 2-1/2" long lag screws with 1/2" flat washers. The concrete floor should be monitored for cracks which may lead to the columns shifting.

Location: Basement

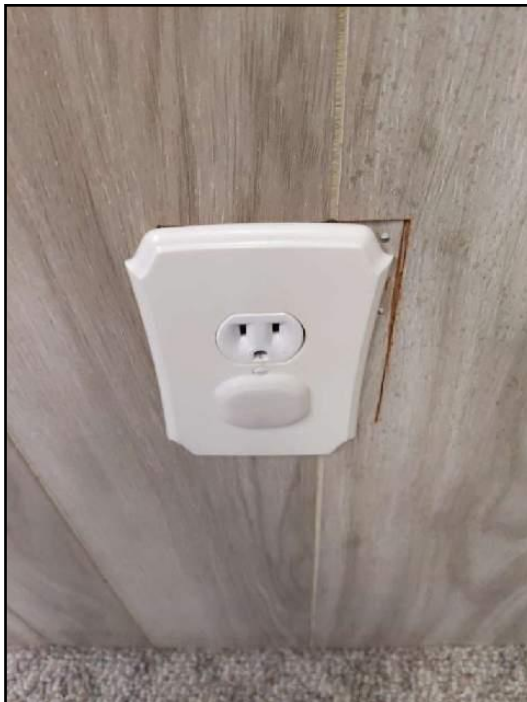
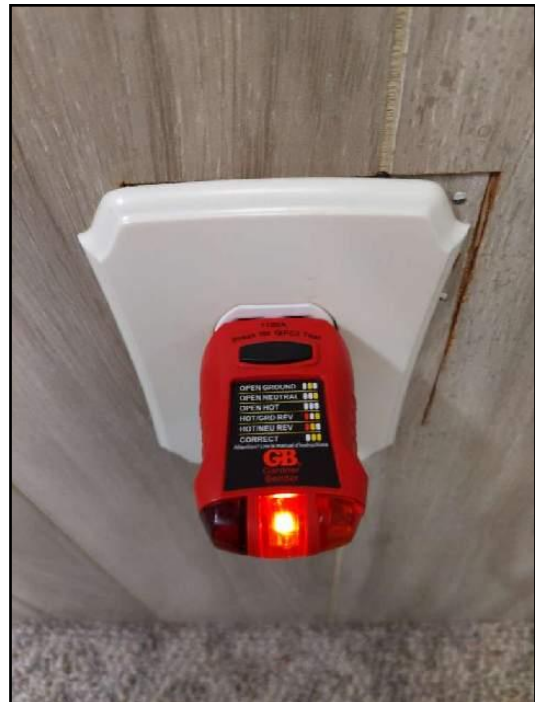
Condition: • [Ground needed for 3-slot outlet](#)

The 3-prong outlets are ungrounded. The outlets should be reverted back to a 2-prong outlet, or replace the outlets to gfci outlets and label the outlets as no ground, or install a gfci breaker in the electrical panel.

Location: Basement

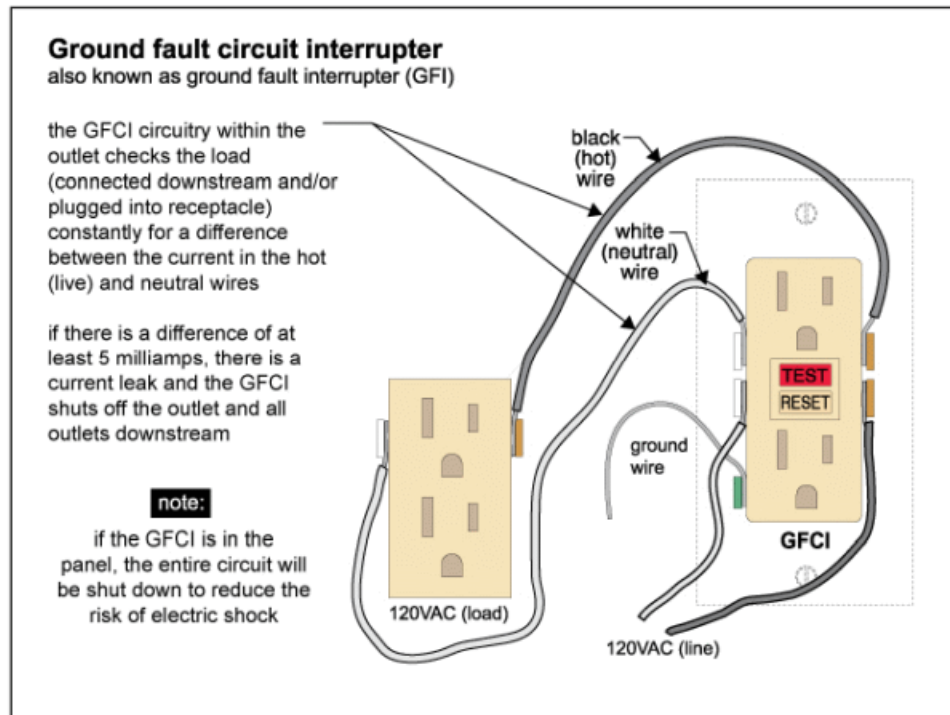
Condition: • [GFCI/GFI needed \(Ground Fault Circuit Interrupter\)](#)

This 3-prong outlet is ungrounded. Due to its location, a Gfci (ground fault circuit interrupter) is needed because moisture can create an electrical hazard. The Gfci should be labeled as no ground for safety.

Location: Front Exterior Wall**Task:** Correct

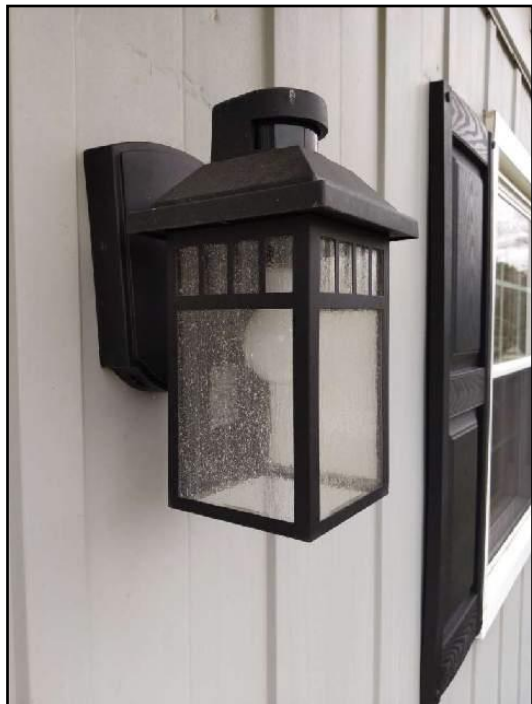
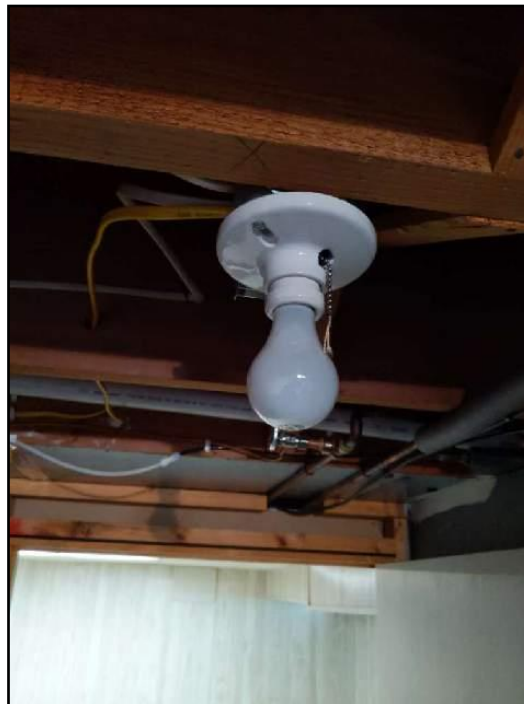
Condition: • [Inoperative](#)

The light bulbs are inoperative. More than likely the bulbs have burned out. The bulbs should be replaced and if the lights are still inoperative, the issue should be repaired.

Location: Exterior Wall Front of Home and Basement Unfinished Portion

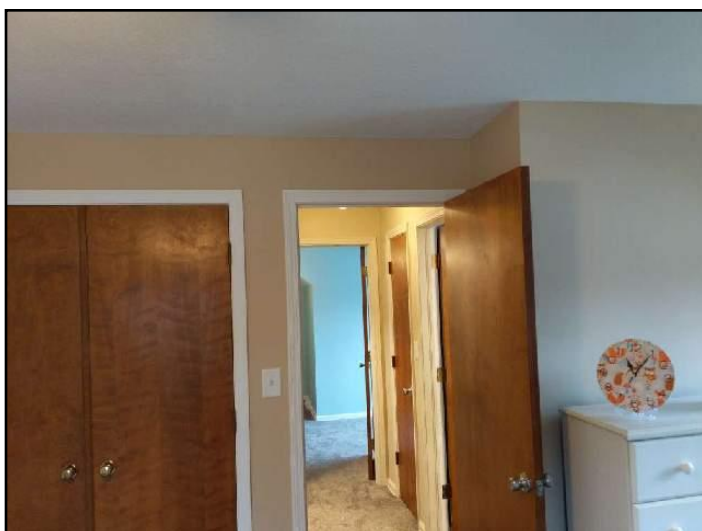
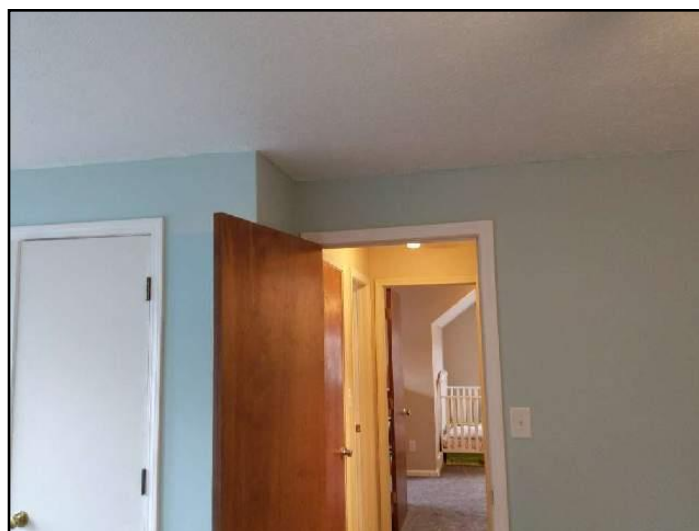
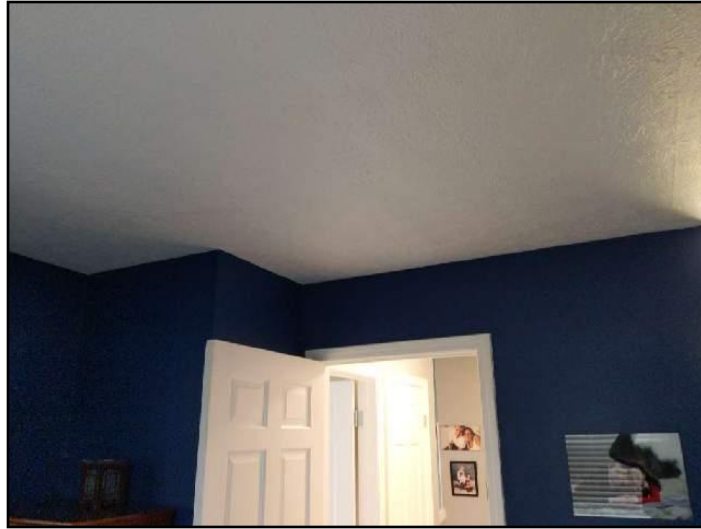
Condition: • Missing

Smoke alarms are missing throughout the bedrooms. Smoke alarms increase life safety during a fire. Smoke alarms should be installed in every bedroom where occupants sleep for safety.

Location: Throughout All Bedrooms

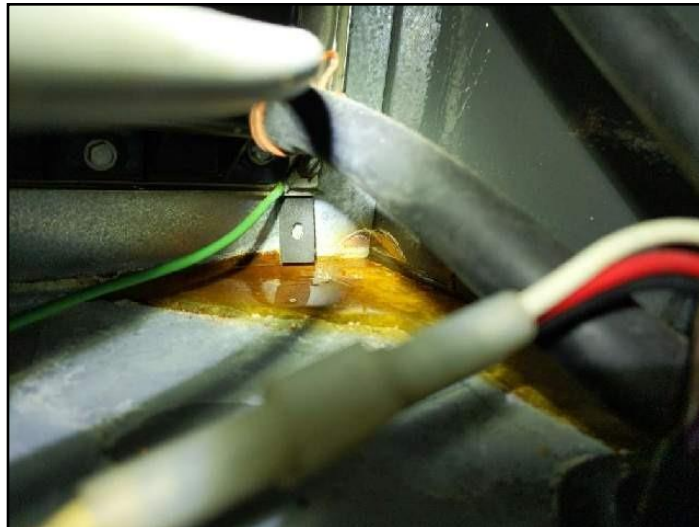
Condition: • [Rust](#)

Rust and water was observed to the upper corner of the cabinet. I recommend hiring a qualified HVAC contractor to evaluate and repair what could be causing the leak.

Location: Basement

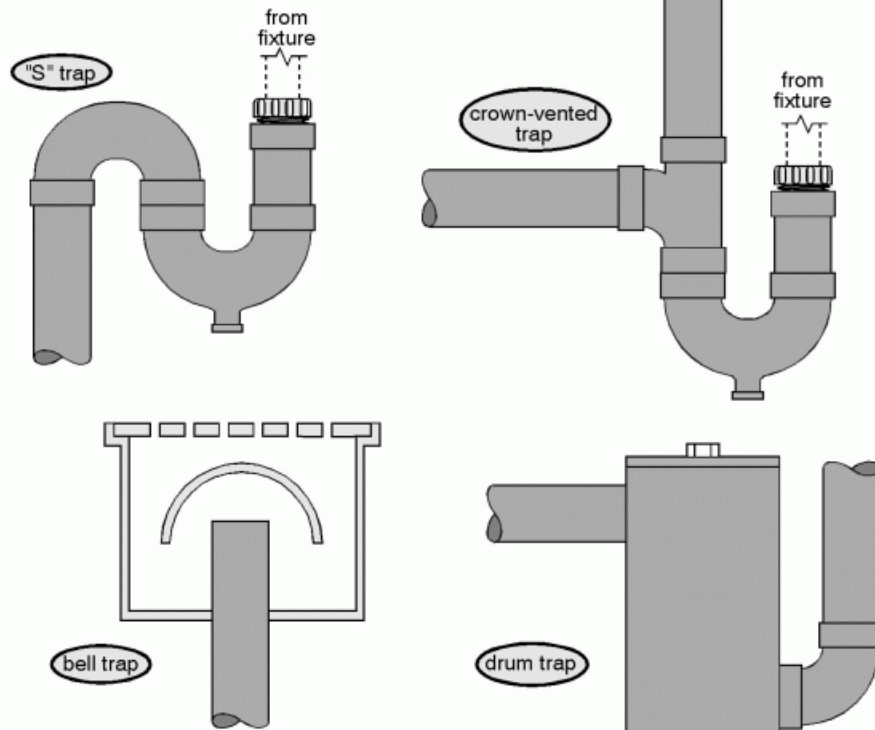
Illegal traps

Condition: • [Wrong type](#)

Task: Correct

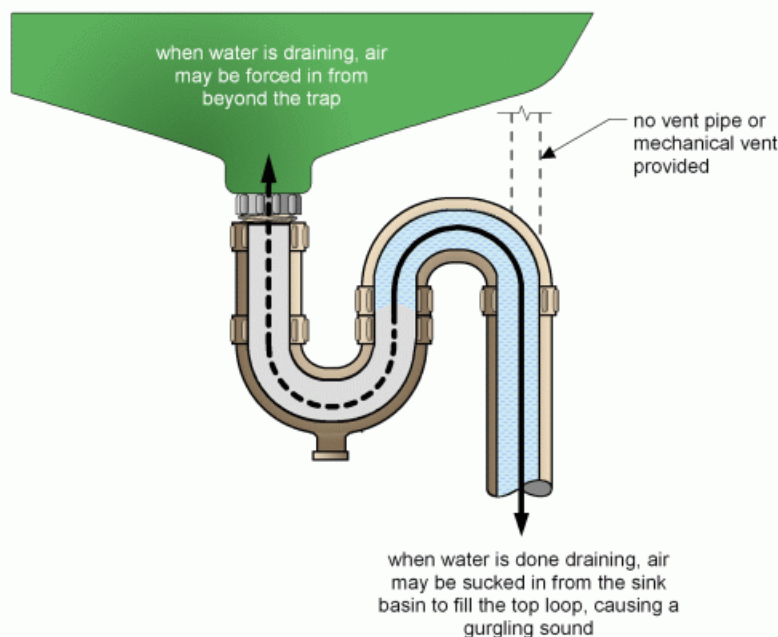
S-traps can lead to siphoning

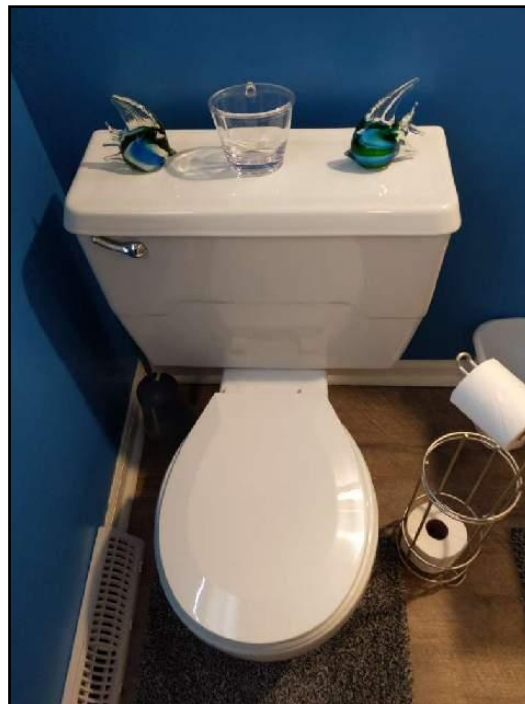
Loose toilet

Condition: • [Loose](#)

The toilet is loose at the flanges. This may cause a leak in the future if not corrected. The toilet should be secured to the flanges properly to avoid a leak.

Implication(s): Chance of water damage to structure, finishes and contents | Sewage entering the building | Possible hidden damage

Task: Improve

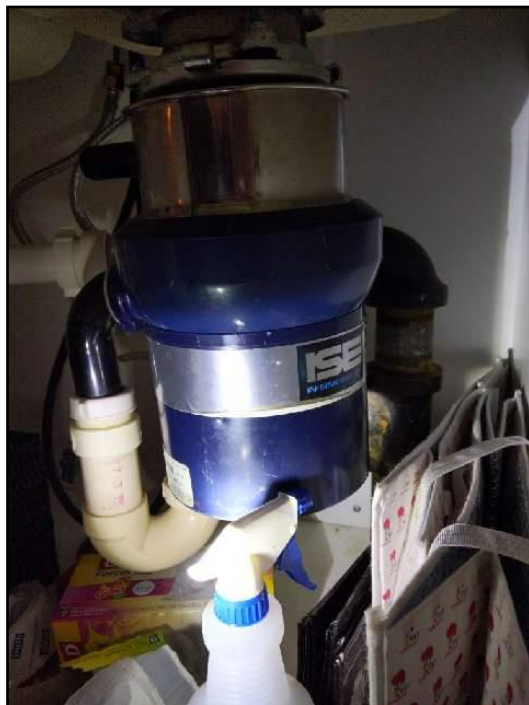
Inventory Garbage disposal (food waste grinder): • In-Sink-Erator

Model number: 333/SS-39 Serial number: PA 55826299

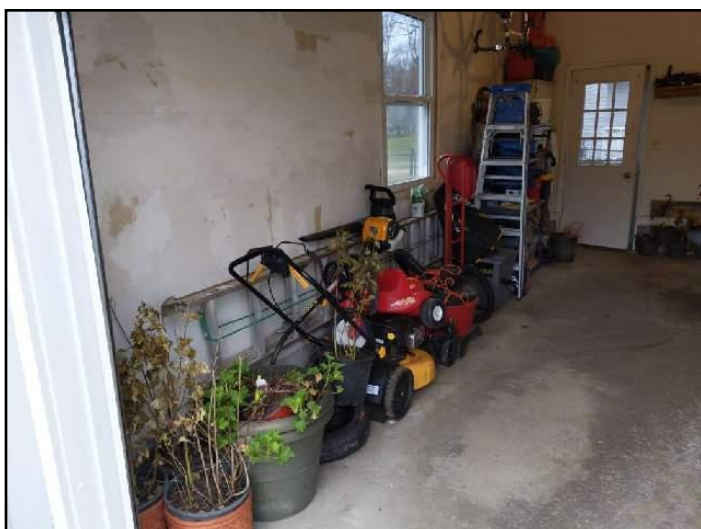
Condition: • Patched

The ceiling has been patched. I recommend asking the sellers for a disclosure as to why the ceiling was patched. The thermal imager did not detect a thermal anomaly.

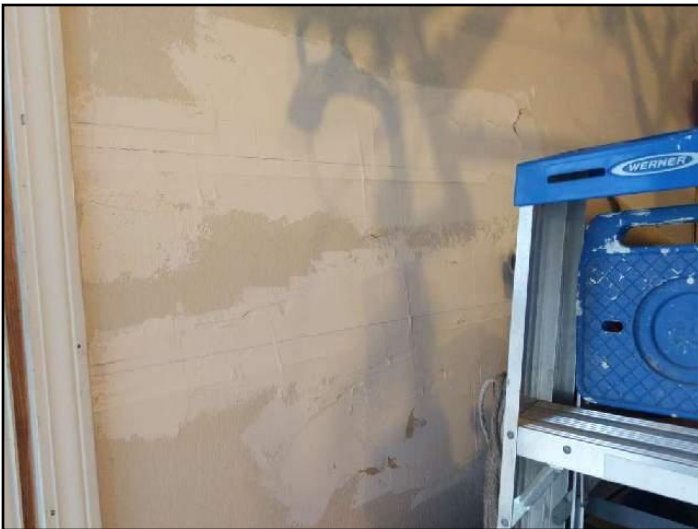
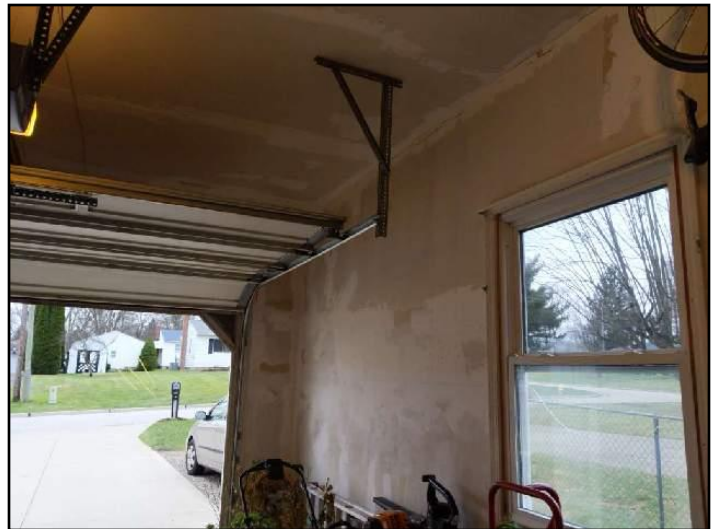
Location: Garage

Condition: • The garage wall and ceiling is under construction. Patching was observed. The walls need scraped / sanded, filled with joint compound, and painted for aesthetics.

Task: Improve

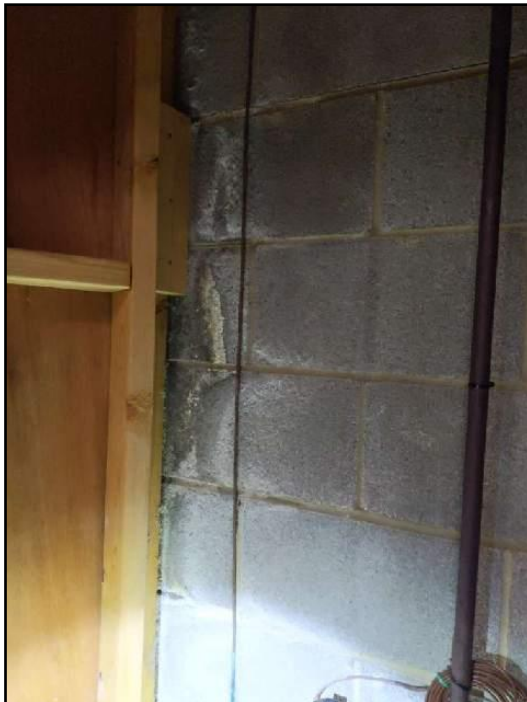
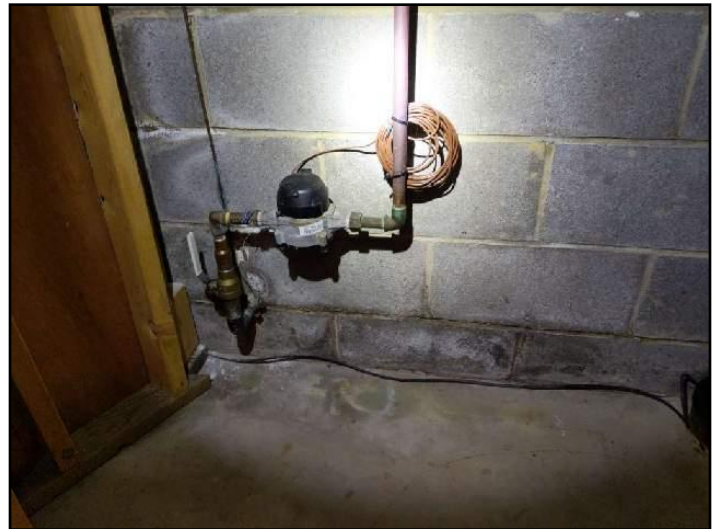
Location: Basement

Condition: • [Efflorescence](#)

Efflorescence is visible on the foundation wall. Efflorescence is a crystalline or powdery deposit of salts often visible on the surface of concrete. It occurs when water leaves behind salt deposits on the masonry surface. The moisture meter alarmed to active water within the blocks at the time of the inspection. I recommend grading the landscaping properly away from the home for proper water drainage and continuous monitoring of this area.

Task: Improve and Monitor

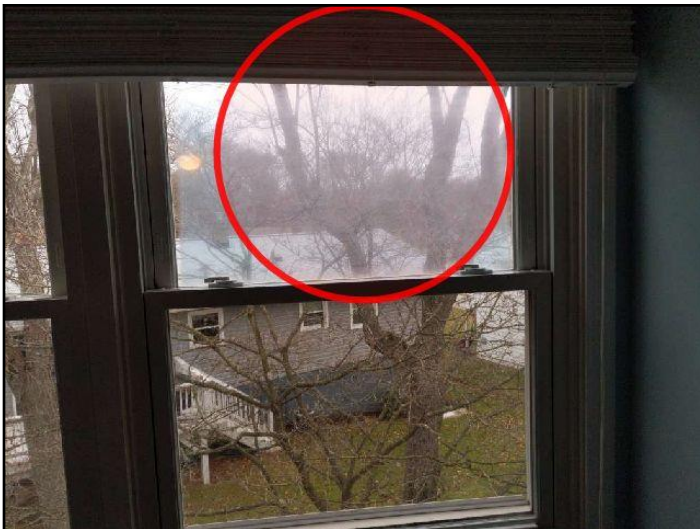
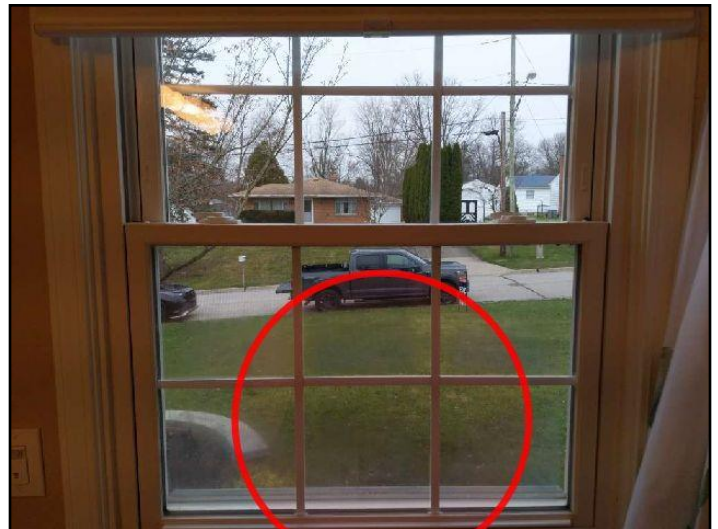
Location: Second Floor West Bedroom, First Floor Bathroom, and First Floor Bedroom

Condition: • [Lost seal on double or triple glazing](#)

The windows have lost their seals, creating a fog between the window panes. Once the seal fails, moisture is allowed to seep into the space between the two pieces of glass. I recommend hiring a qualified window contractor to repair the windows.

Task: Repair or Replace

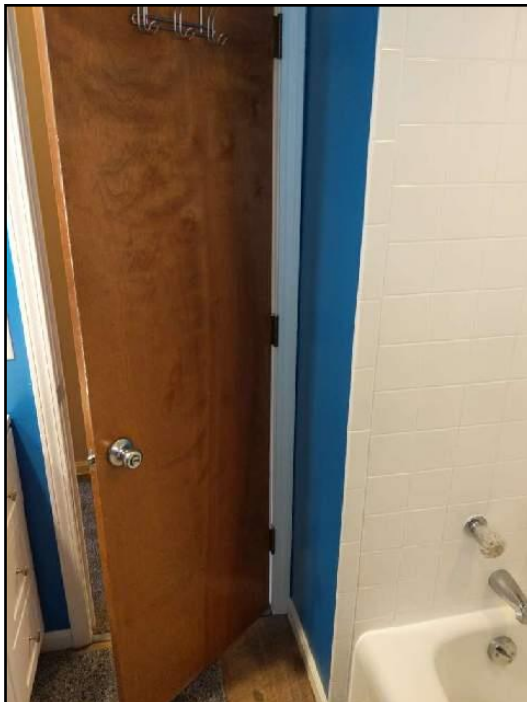
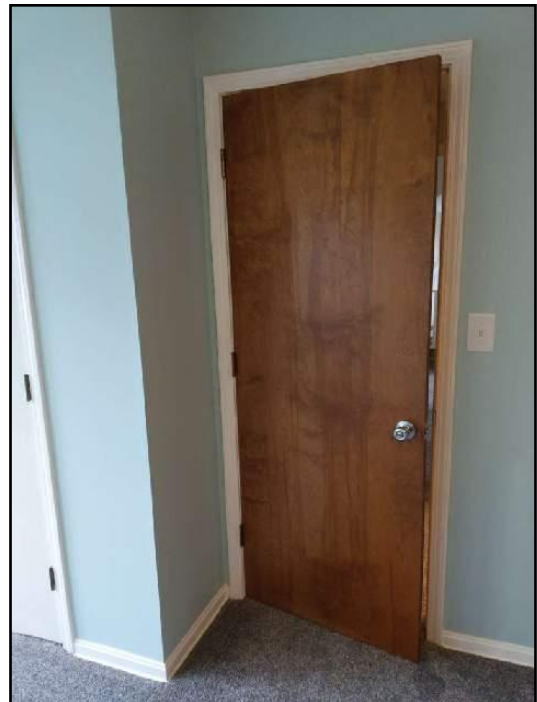
Location: Second Floor Bathroom, Second Floor West Bedroom, and Basement Door

Condition: • [Doorstops missing or ineffective](#)

Door stops are missing. Door stops help prevent the door hardware from coming in direct contact with and damaging the wall.

Task: Improve

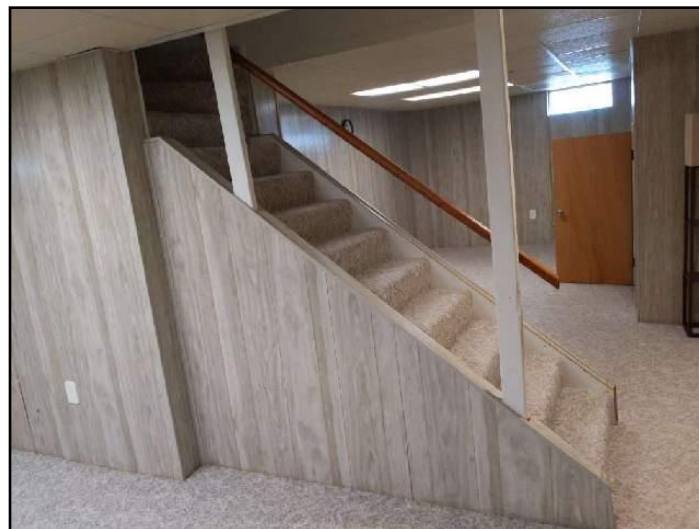
Location: Basement Stairway

Condition: • [Missing](#)

Vertical guardrails are missing. This poses a safety issue especially with smaller children. Vertical guards spaced four inches apart should be installed for safety.

Task: Improve

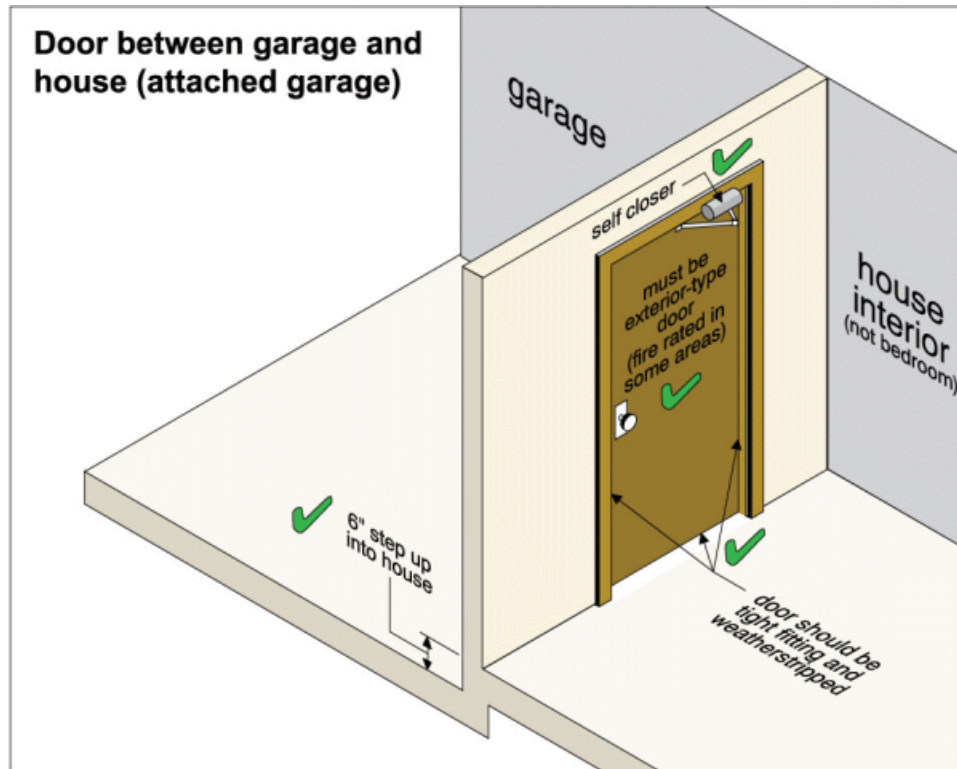
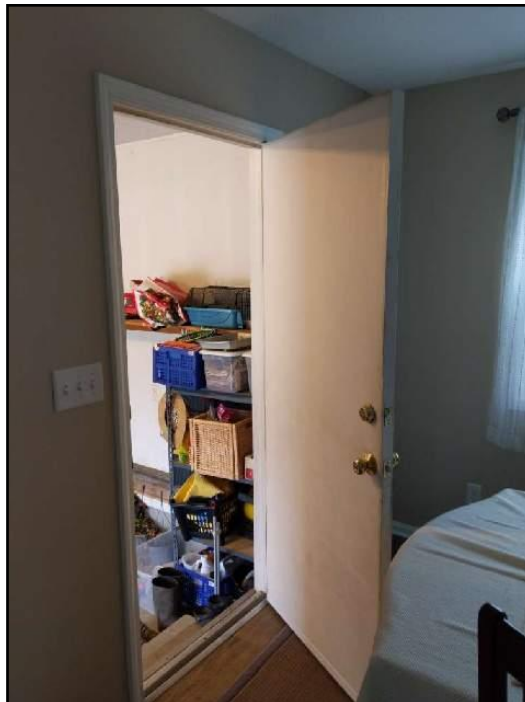
Location: First Floor Garage Entrance

Implication(s): Hazardous combustion products entering home

Task: Improve
